Put Your Lights On:

Design and Construction of a Large UV Facility at Central Valley WRF, Utah

by Cynthia L. Bratz, P.E.

October | 2010

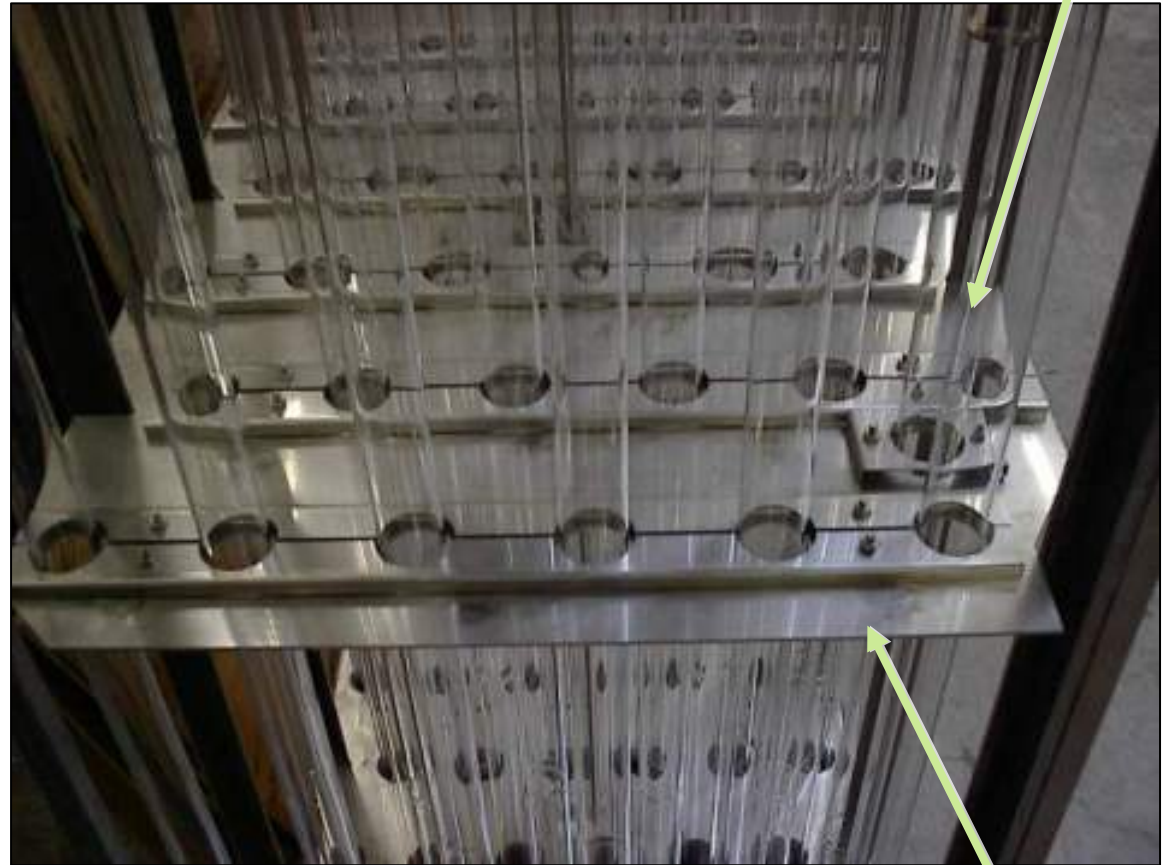
Aquaray® 3X H0

- Mechanical Sleeve Cleaning System

Sleeve for UV
Intensity Sensor

Wiper Plate

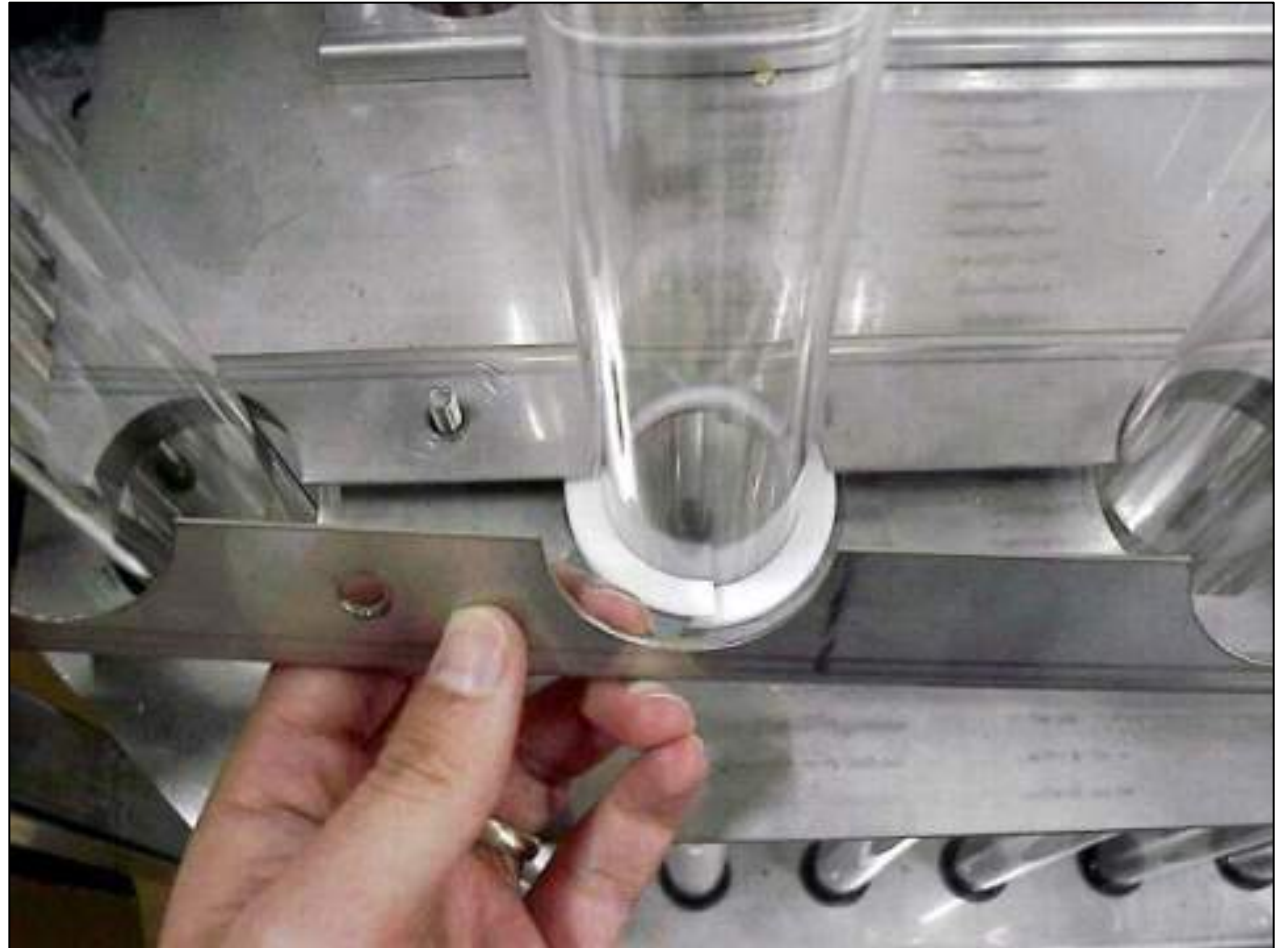
Aquaray[®] 3X H0

- Mechanical Sleeve Cleaning System
 - Patented Quick Change Wiper Ring

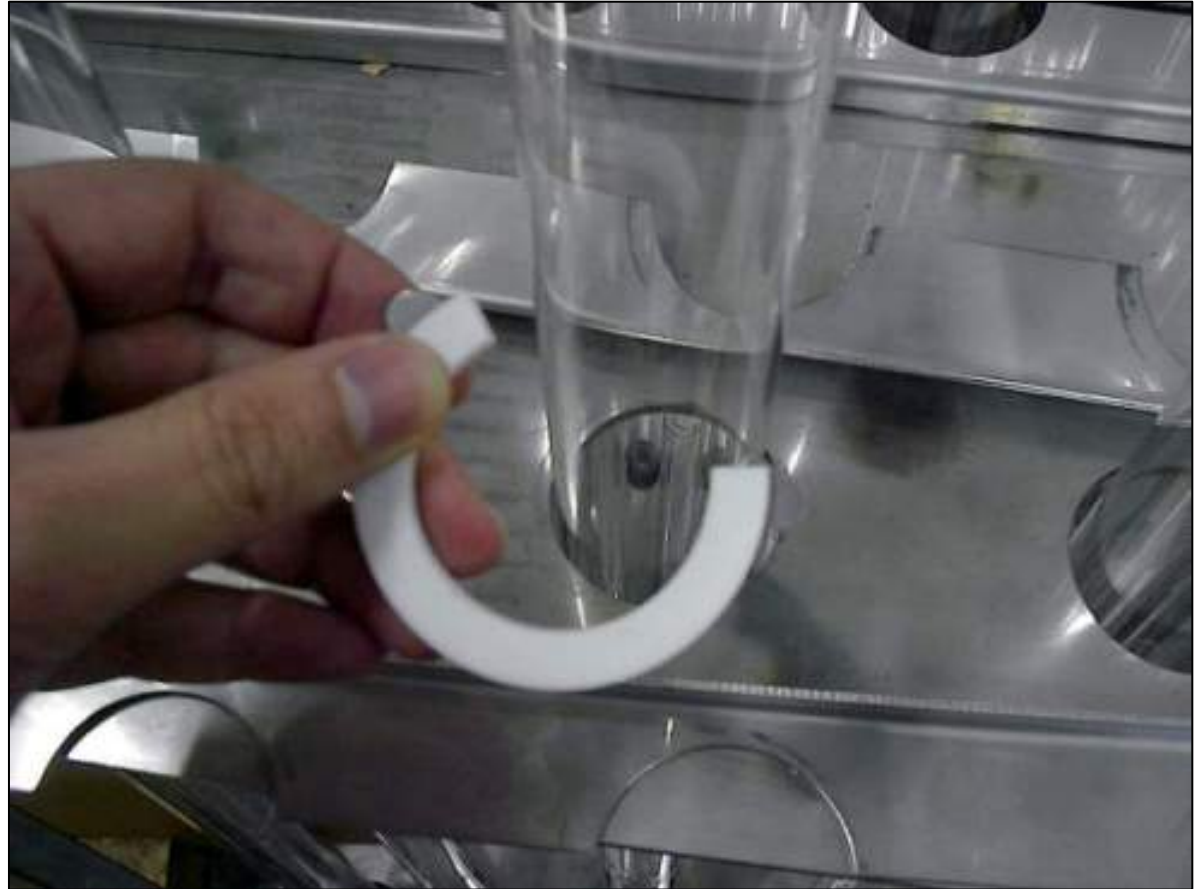
Aquaray® 3X H0

- Quick Wiper Change

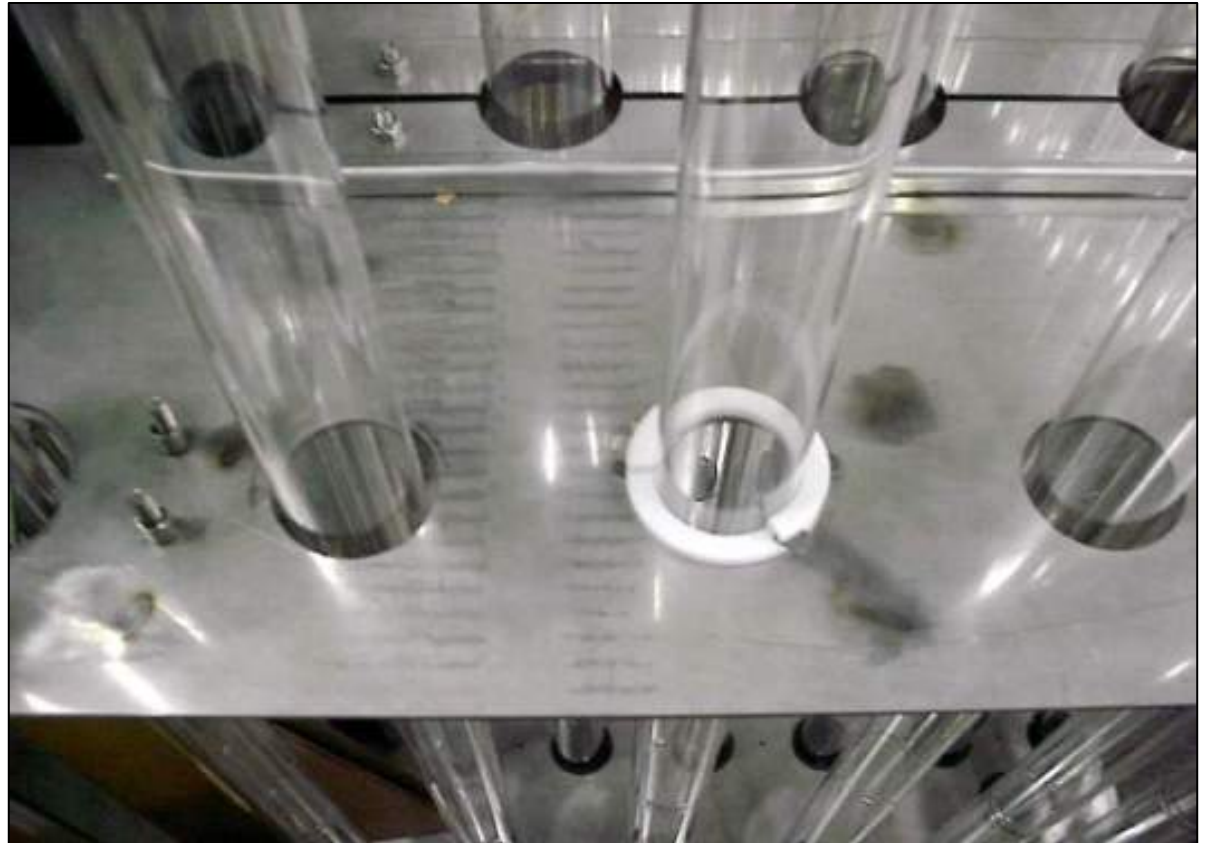
Aquaray[®] 3X H0

- Quick Wiper Change

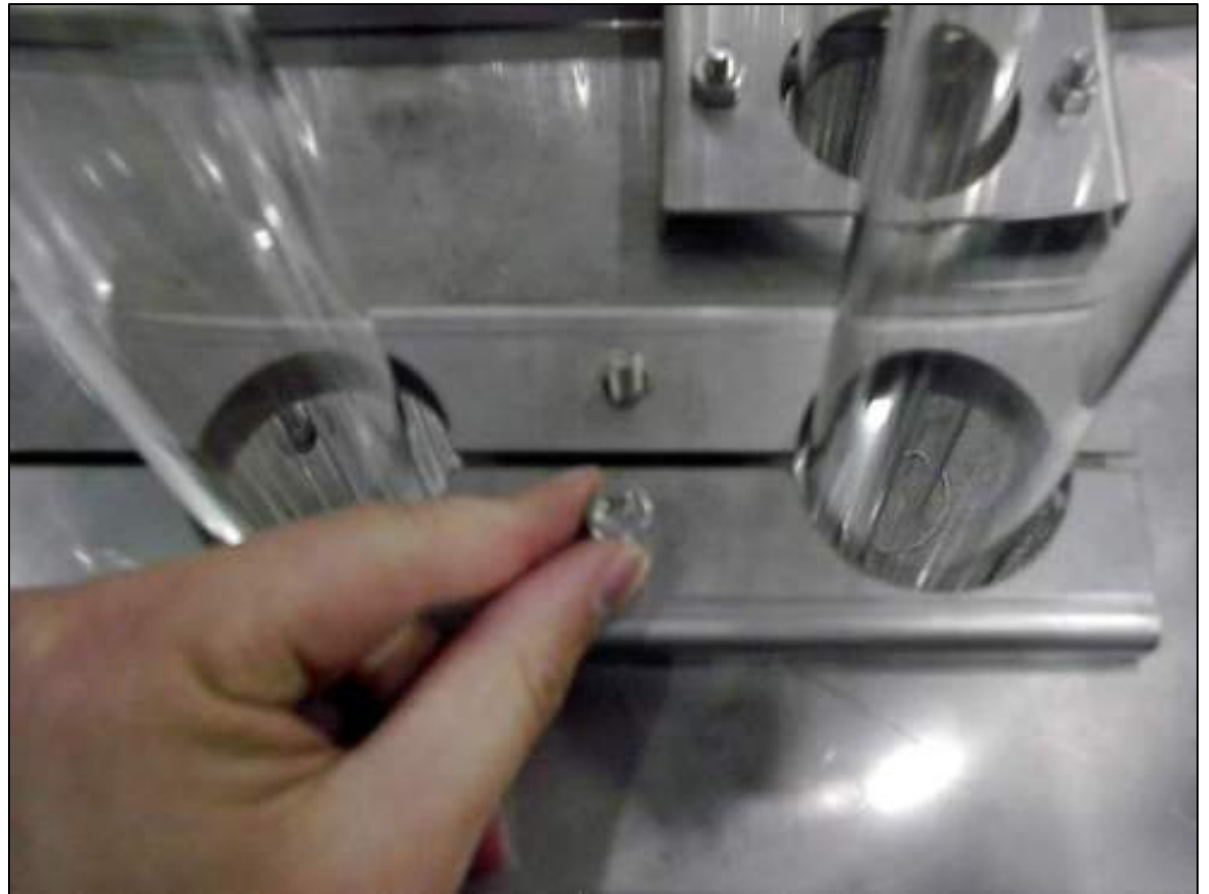
Aquaray[®] 3X H0

- Quick Wiper Change

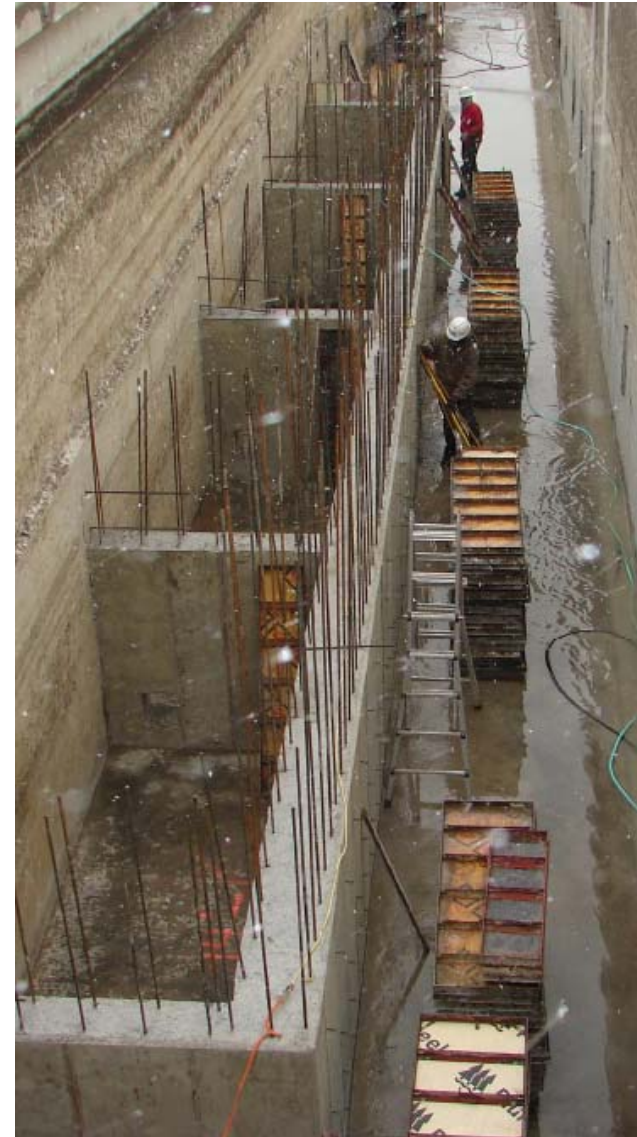
Interesting construction sequencing:

- Maintained south basin on line for chlorination / dechlorination
- Took north basin offline and built effluent boxes
- Sawcut basin center wall but braced in place so channel could be placed back online

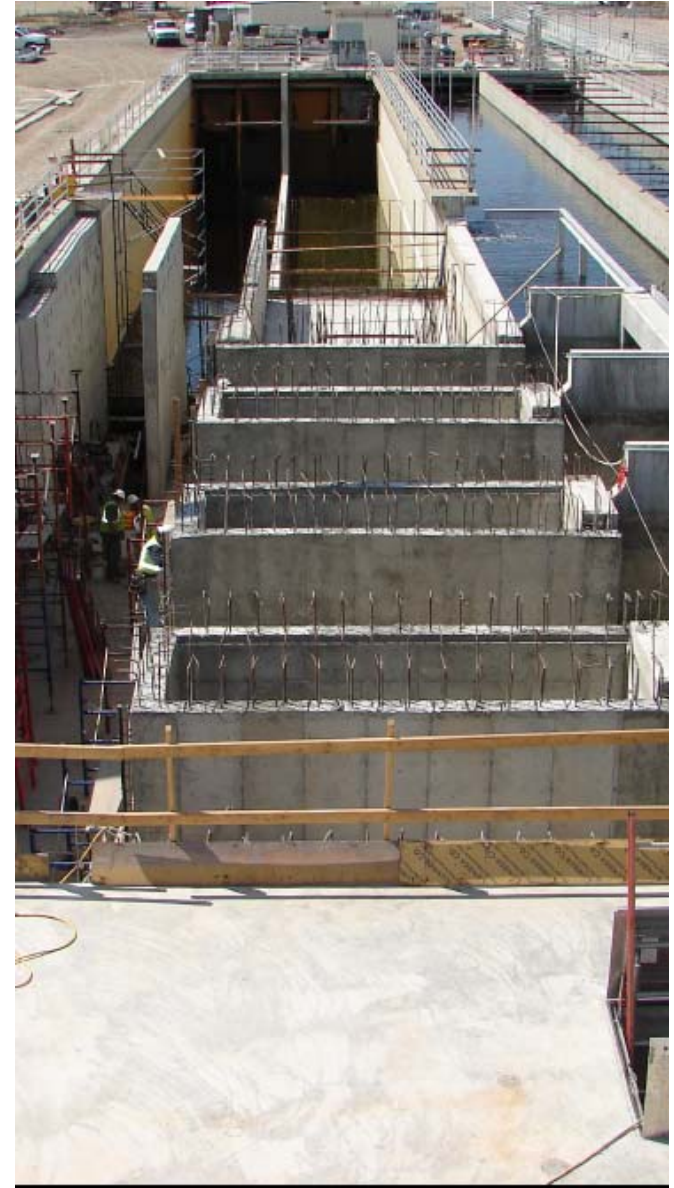
Interesting construction sequencing:

- Placed north basin back in service
- Then took south basin offline and built UV channels and building
- Chlorine contact basin walls needed additional thickness to support new facilities

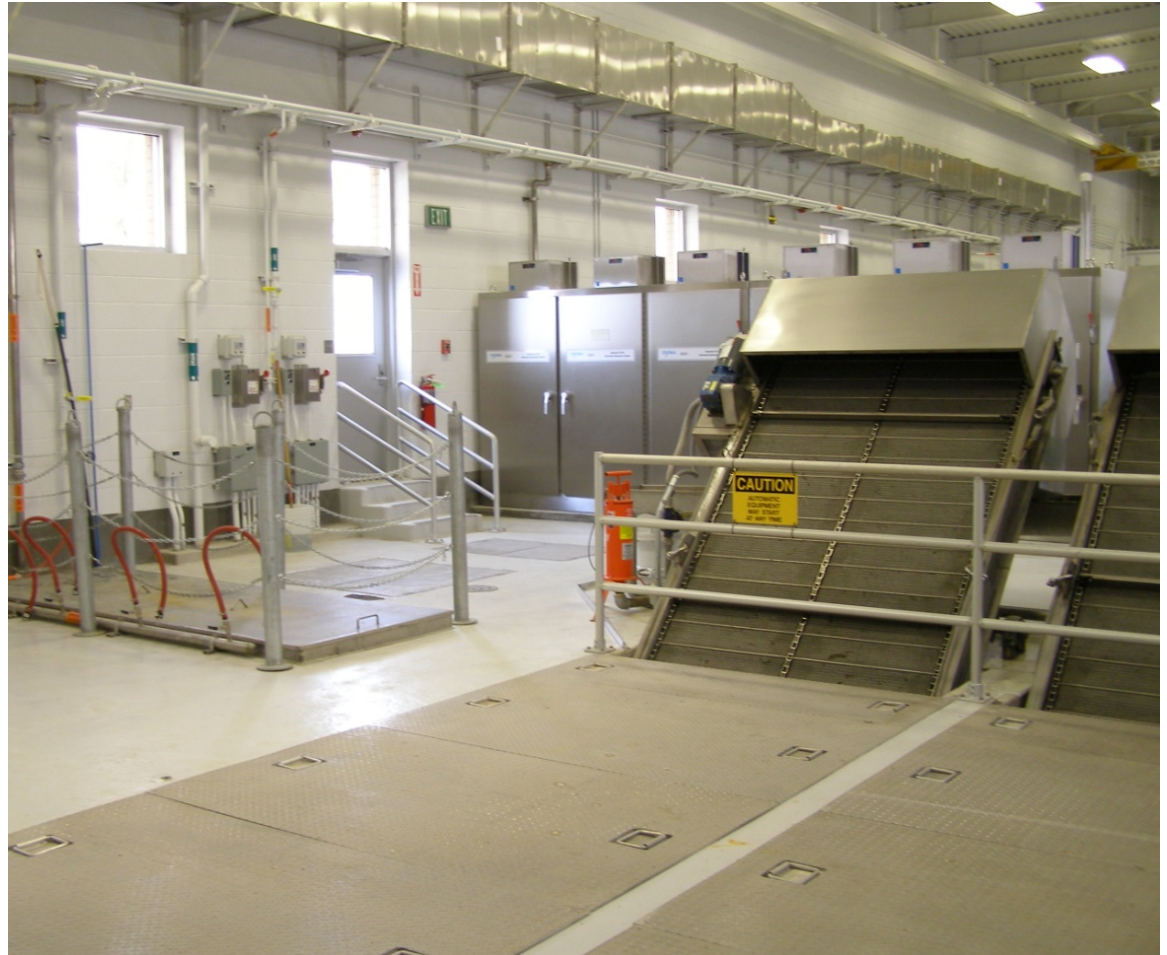
Algae screens:

Interesting features of this facility:

- Algae screens by International Water Screens – canal screen
- Needed low headloss screen
- Needed unit which could span a wide channel
- Standard WW screen not necessary
- Lower cost unit desirable

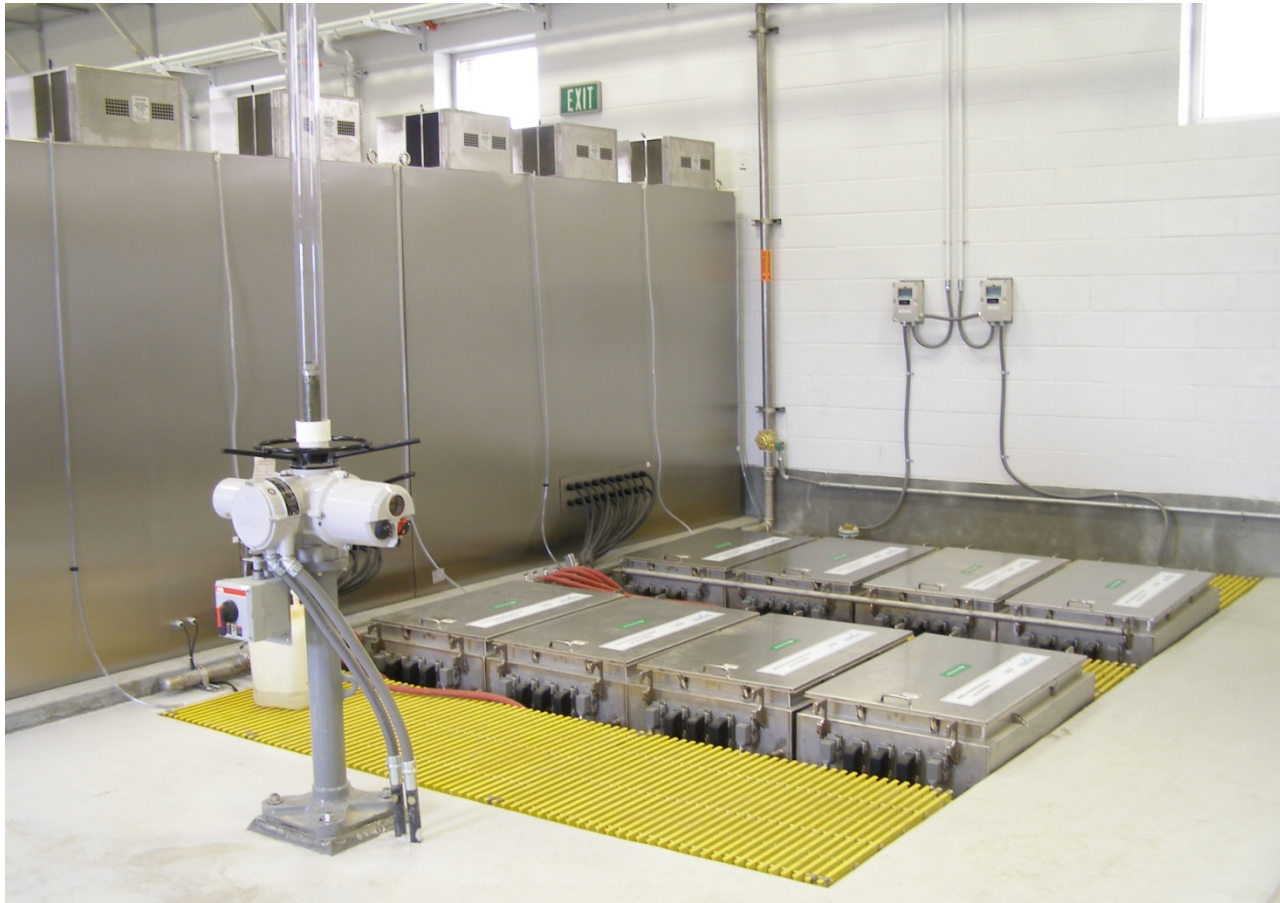
Interference with Milltronics level sensors

- UV modules emitted an ultrasonic signal which interfered with the Milltronics ultrasonic sensors on the effluent gates (for level control)
- Replaced with a different manufacturer's ultrasonic sensors – no interference

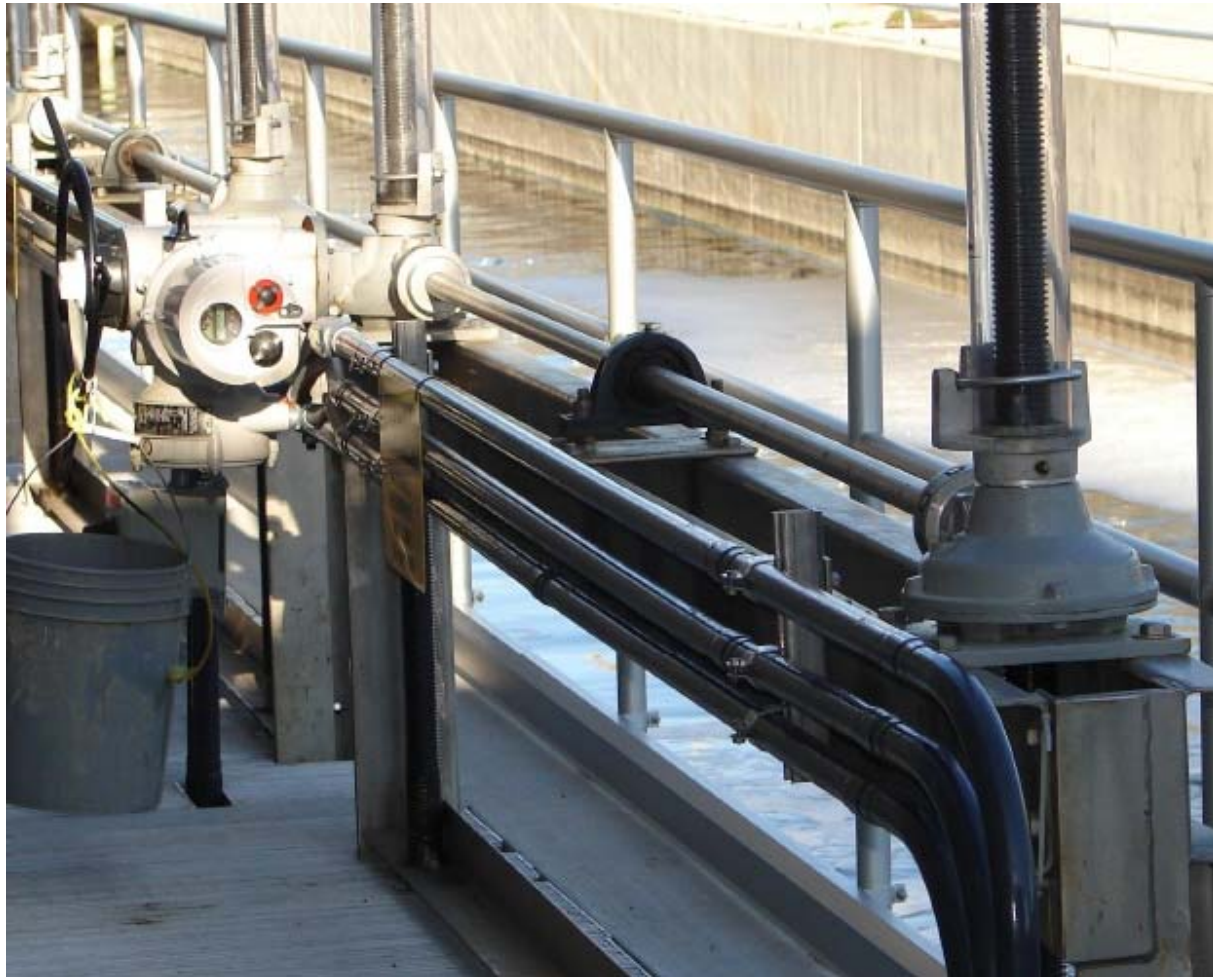
Interference with Milltronics level sensor

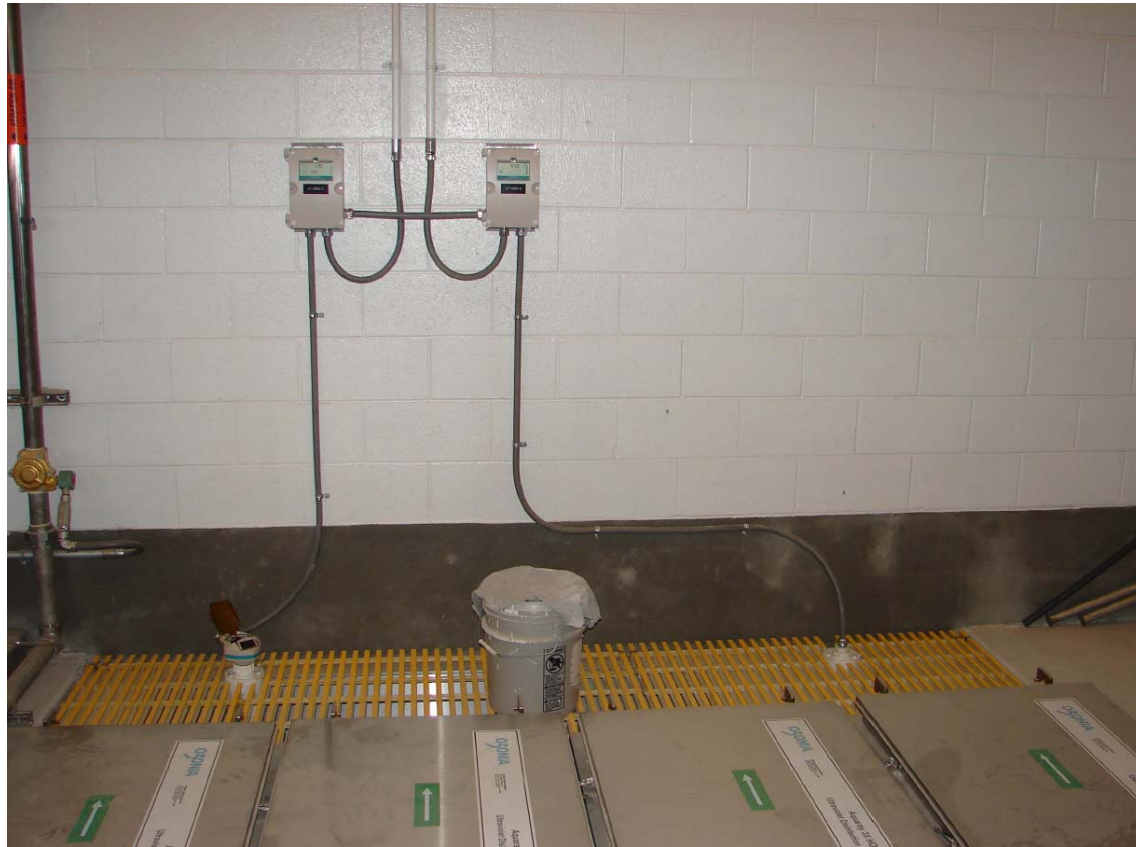
Interference with Milltronic level sensors

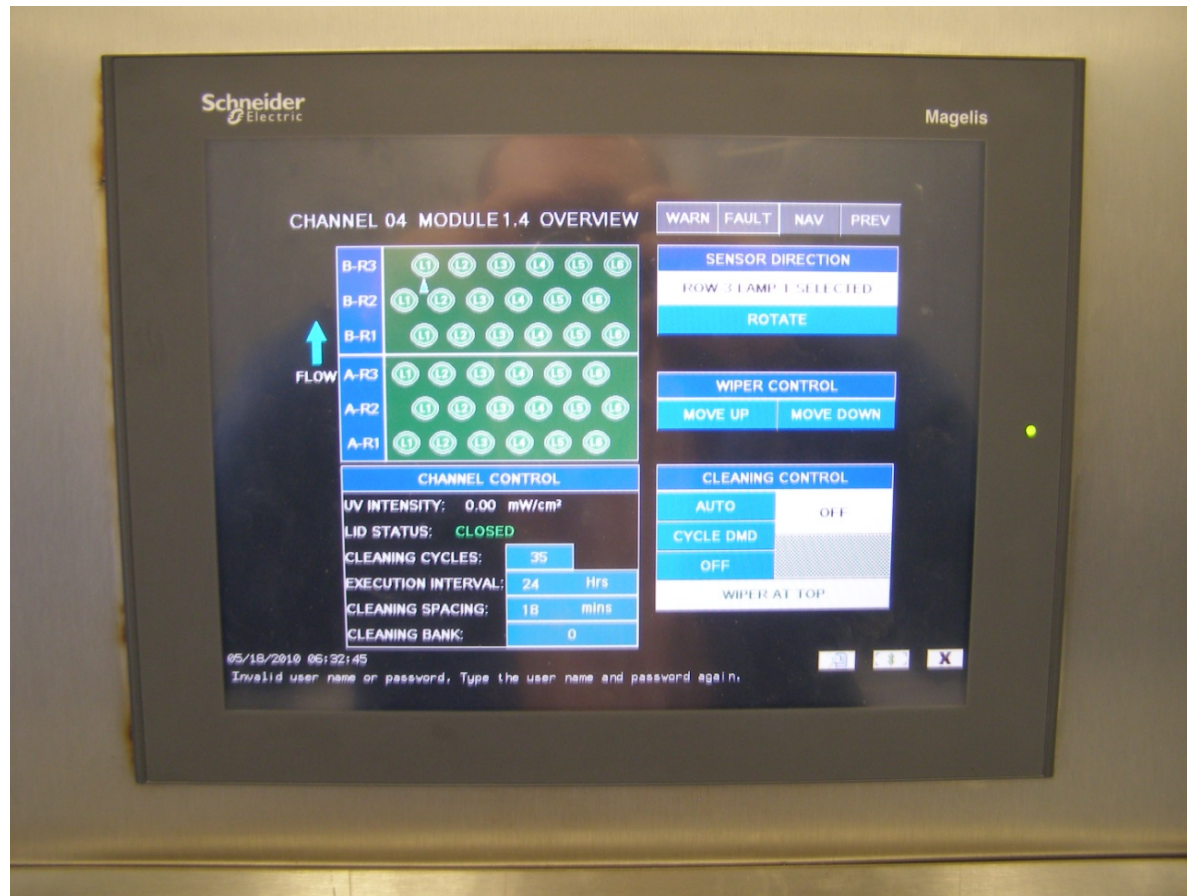
Control system
